Vanaheim Technologies Ltd

Quotation For Supply

Quote for repair to the Carbon Fibre Finn Mast as discussed is as follows.

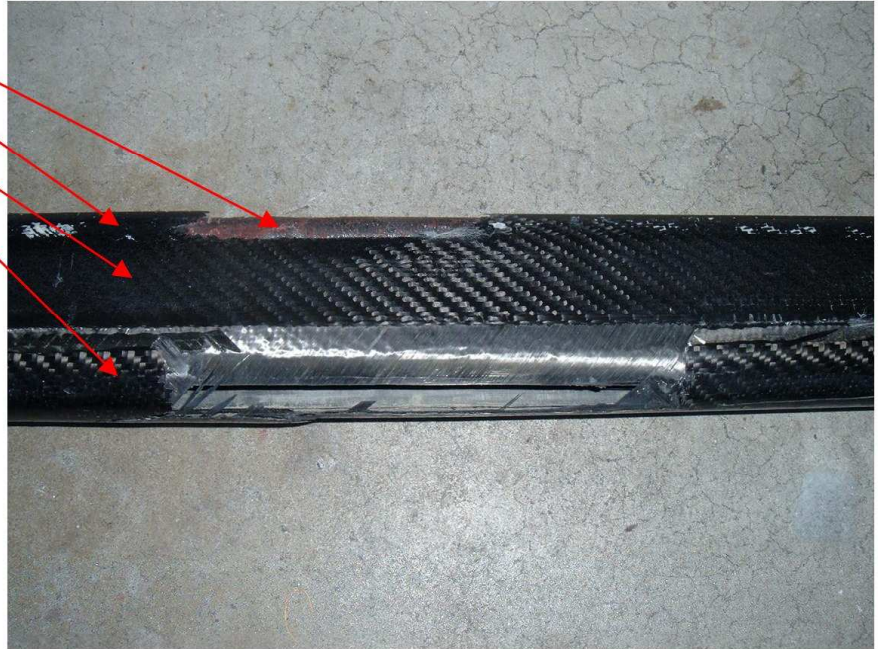
Bottom (3800mm) Crush Damage

Mast has suffered crush damage consistent with being run over by a car or similar. This damage is located 3800mm and 5300mm respectively from the heel of the mast.

As a result of the crush damage the leading edge of the mast has cracked and in some sections separated from the basic mast structure between 2800mm to 5500mm from the heel of the mast. At the crush points damage has occurred to the sail track support structure. The sail track is undamaged and retains its structural integrity.

The basic mast structure has slight cracking at the crush points. As the mast section was crushed, the leading edge and sail track support structure cracked along the joins allowing the two separate parallel components of the basic mast structure to flex inwards. As the crush load was removed they simply reflexed back to their original positions.

- Sail Track
- Sail Track Support
- Basic Mast Structure
- Leading Edge

- 1- Removing the leading edge between 2800mm to 5500mm from the heel of the mast to expose mast internals.
- 2- Internally repairing cracked and or missing sail track support structure.
- 3- Crack testing the basic mast structure and internally repair as required.
- 4- Making up a male mould to manufacture new leading edge section.
- 5- Laying up the new leading edge section.
- 6- Gluing the new leading edge to mast section.
- 7- Testing mast bends to known Finn class mast bend graphs.
- 8- Filling, fairing and repainting mast section.
- 9- Replacing the canvas protective transport cover.

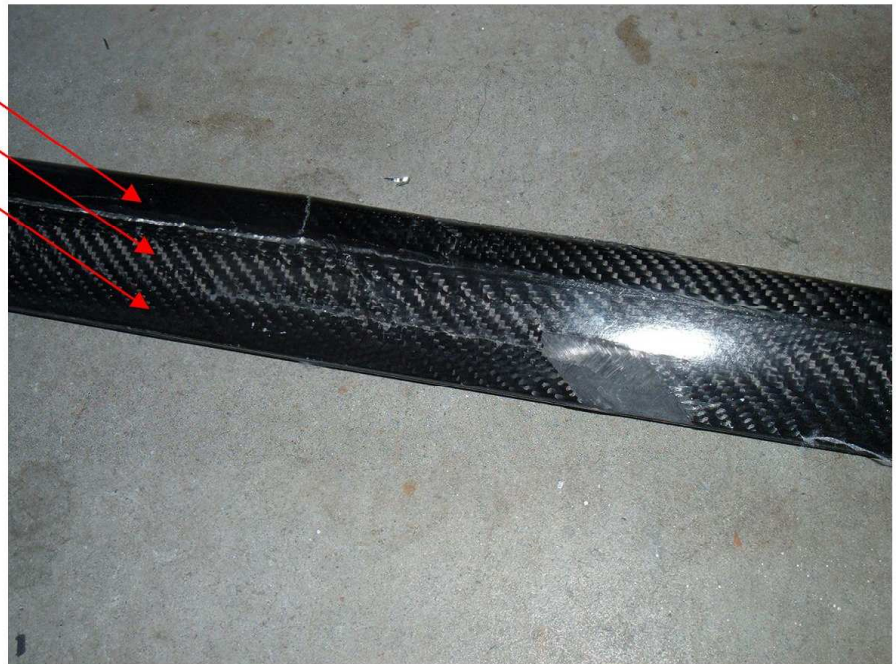
Top (5300mm) Crush Damage

- Sail Track Support
- Basic Mast Structure
- Leading Edge
